# Hotsprings Road Rural Residential Subdivision Draft Environmental Screening

November 2005

INUKSHUK PLANNING & DEVELOPMENT

# Hotsprings Road Rural Residential Subdivision Project Description

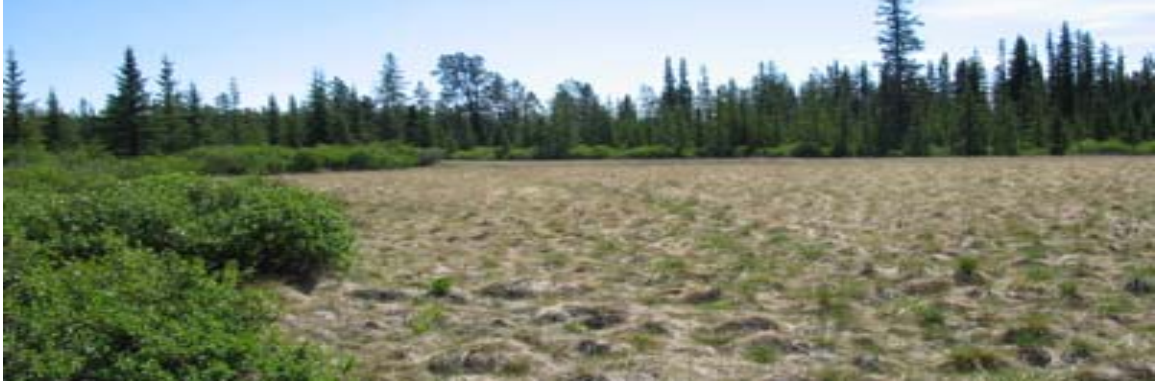
Main meadow, west side of study area with willow shrub perimeter

The topography, soils and gradient determine the surficial drainage. There are no permanent or ephemeral watercourses present. As noted by EBA, groundwater was only encountered in test pit #1 at 3.2m within the meadows where expected. Generally, the sandy soils permit rapid infiltration of surface runoff. Even the meadows that are in shallow depressions are generally dry in most years. This is supported by the percentage of grass cover as opposed to sedges and related plant species that are commonly associated with a perched or near-surface water table. The test pit data does not suggest a perched condition is present.

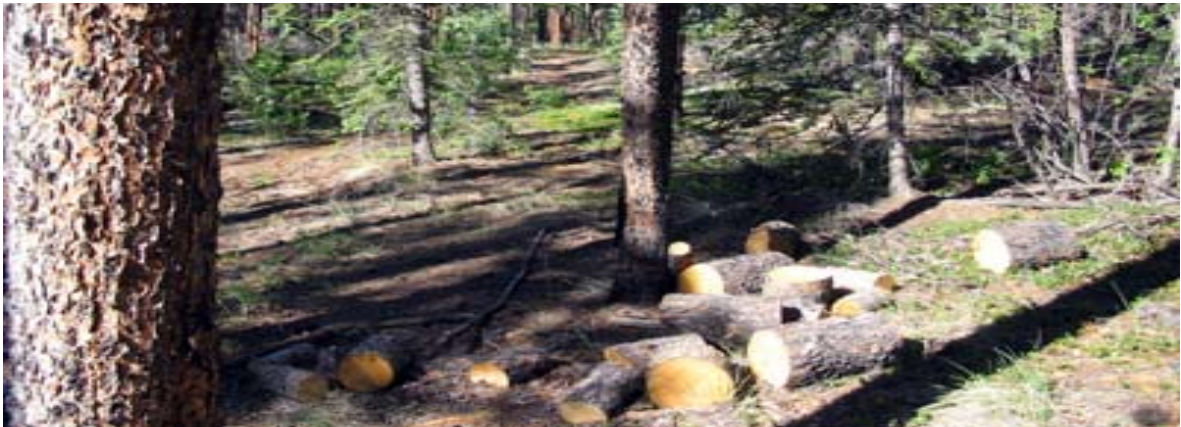
Woodcutting Activity June 2005

Approximately 6 individual woodcutting permits are issued each year covering the north-central portion of the study area. These permits are for personal use only and only for dry or dead wood according to Todd Pilgrim of Energy Mines & Resources Client Services & Inspections. Cutting outside the permit area behind Gruberville was observed during site visits and this included the removal of live and wind blown trees. The net result of the activity to date has been to reduce the fuel capacity and associated forest fire risk. The proposed

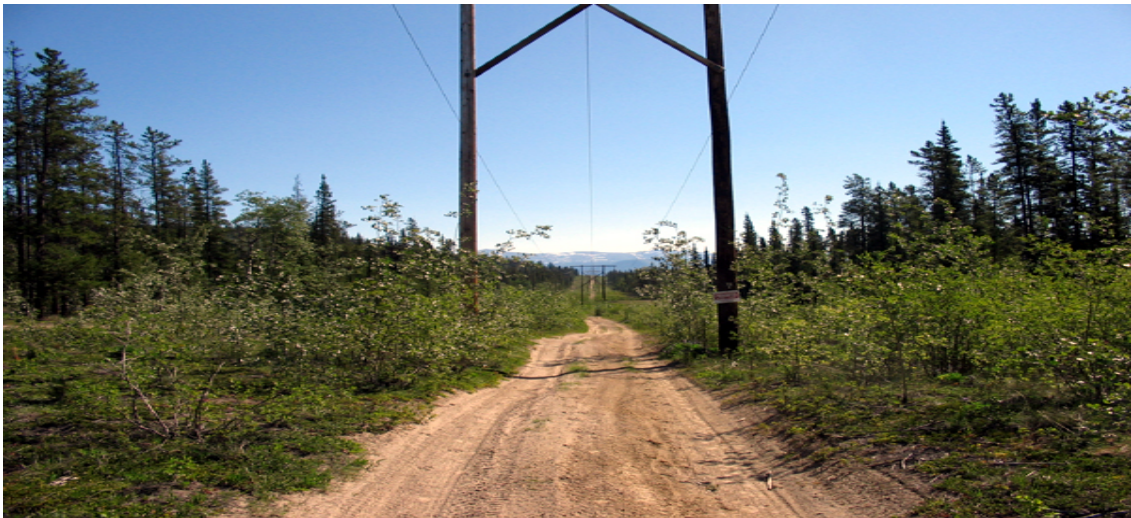
138kv Power Line ROW is also a well-used recreational corridor

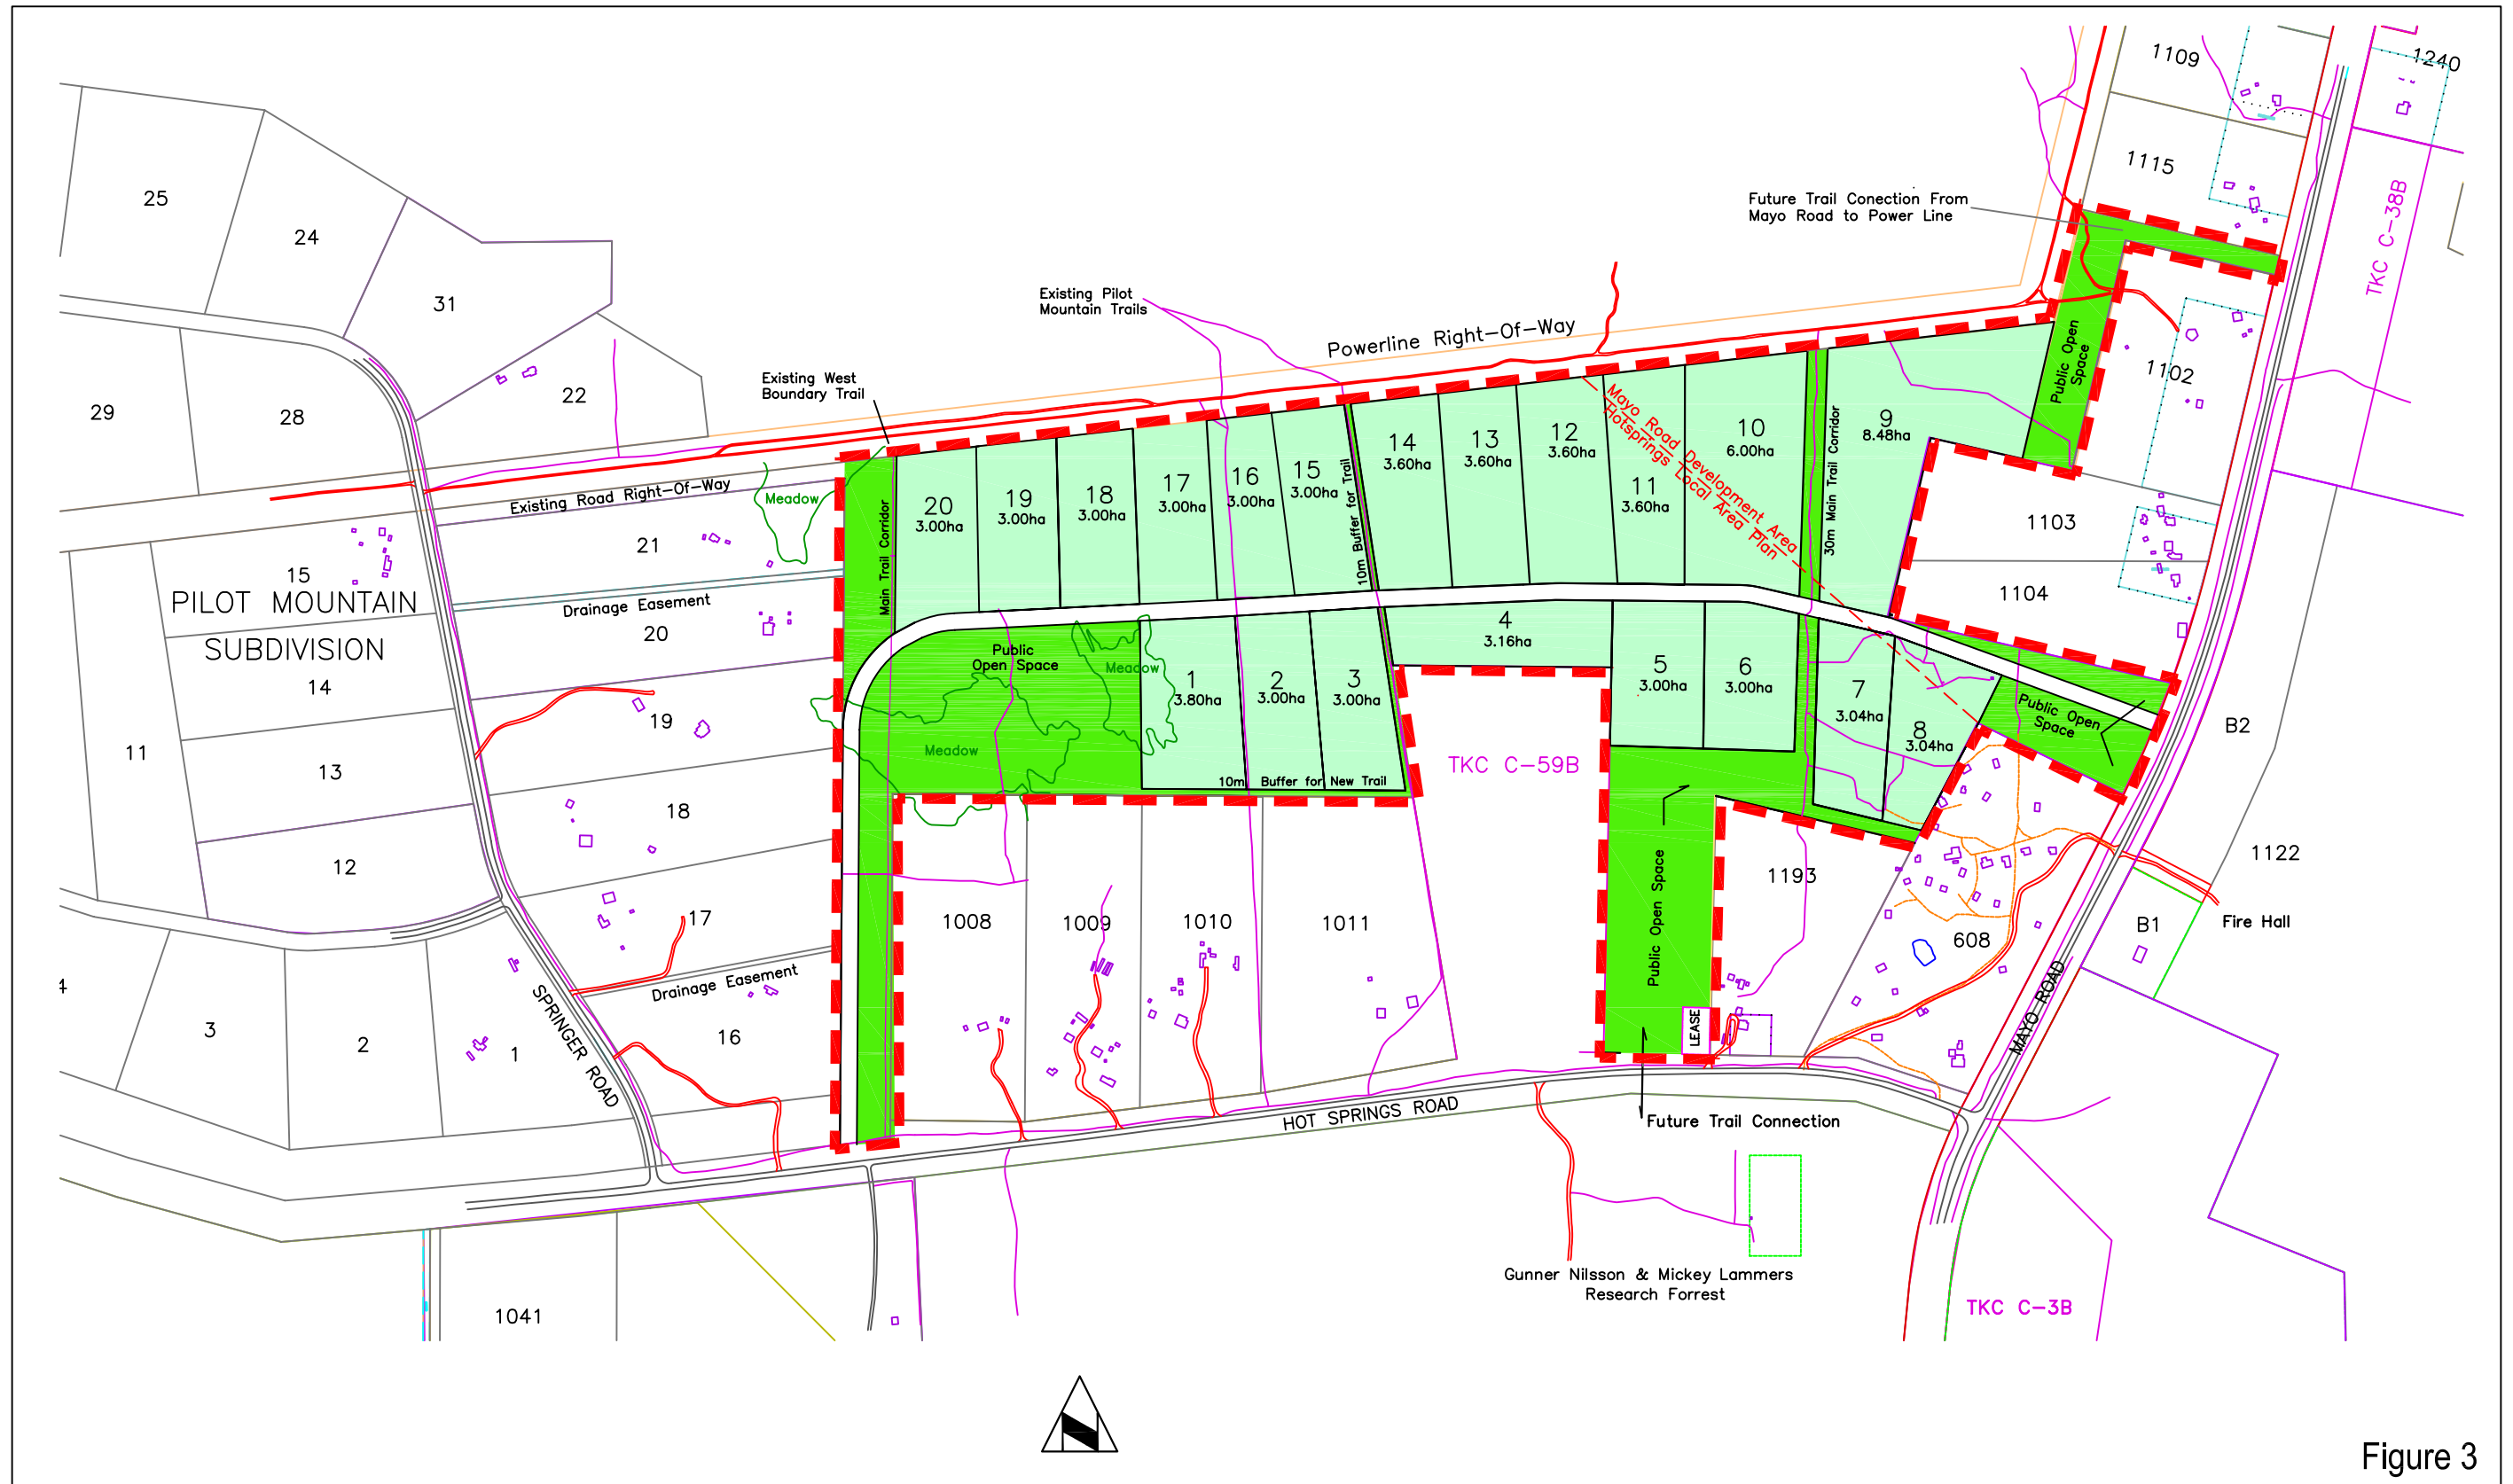
Figure 3

Hot Springs Road Rural Residential Subdivision  
Final Subdivision Plan

The design retains 27% of the study area as public open space and trails, well in excess of the minimum 10% requirement. The two main existing trails are retained along with a central greenway connection between the Research Forest and the power-line right-of-way to the north. The two main meadows are retained for public open space and a Springer Road connection has been dropped at the request of the property owners most affected. The Hotsprings Road connector follows the back of 4 properties that front on Springer Road because these property owners expressed interest in subdividing these properties while the owners of the lots fronting on the Hotsprings Road did not. Allowance for a future trail connection from the Mayo Road to the 138kv power line was also provided in the northeast corner of the site. As the owner of lot 1104 had cleared a substantial amount of land behind their property and was concerned about security and vandalism, the Mayo Road access point was shifted slightly south to provide a small triangular shaped treed buffer. A new trail access was also provided from Gruberville to the main east side trail as part of the present trail crosses lot 1193. The present leased land used by this same lot owner as a corral is left in tact but can be consolidated with the adjoining greenway on expiration of the lease if so desired.

The lots are all between 3-4 ha in size except for two lots that are mainly within the Mayo Road Planning Area where the minimum lot size remains 6 ha. Although this boundary is an artificially imposed line bearing no relationship to any logical land use boundary, the compromise reflects area resident wishes. While some area residents remain opposed to any development of this area, the modifications proposed in the final plan accommodate the majority of local concerns.

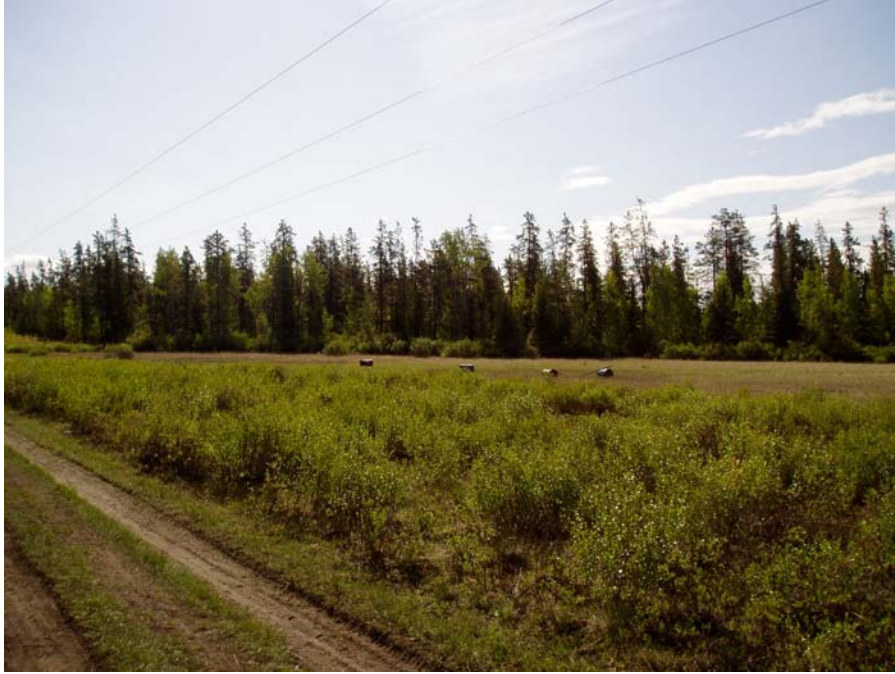
Figure 2: Photo of the northwest corner of the development area.

The heritage assessment was completed by walking and driving transects through the study site with the intention of observing and documenting 1) sites that may have elevated potential for presence of heritage sites, and 2) surficial historic resources. In the former case the consultant focused primarily on the northern portion of the study area where base of Pilot Mountain where some elevated topography does exist (Figure 3). A program of shovel tests was not undertaken within the study area.

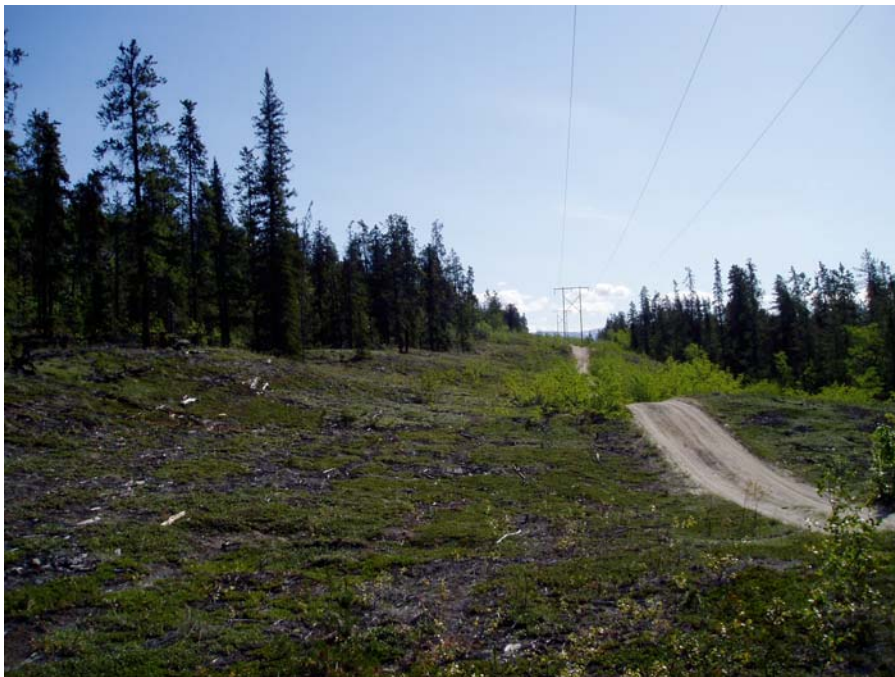
Figure 3: Elevated hills at the border of the development area.

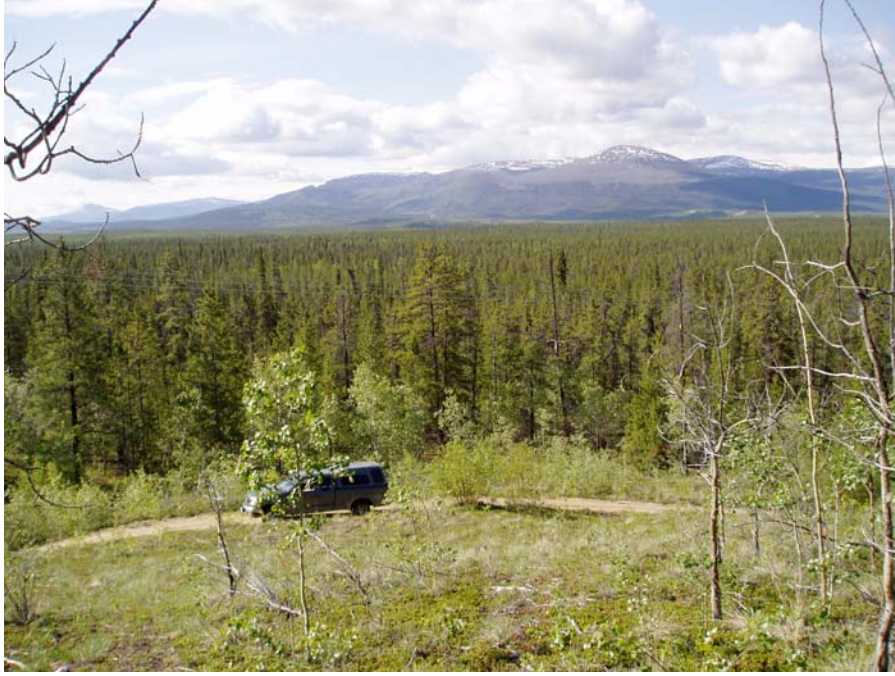
Figure 4: View to south of the forested development area. Note the lack of elevated terrain features.

The study site is directly to the south of Pilot Mountain on a low flat forested plain that is underlain by sands of either fluvial or eolian origin. The local vegetation is composed of closed white spruce forest with an under growth of grass, shrubs and moss (Figure 4, background). Linear transects of the study site revealed no prominent topographical variances from east to west. As one moves from south to north the topography begins to rise at the base of Pilot Mountain. No moving or standing water bodies exist within the study site.
